Miscellaneous Paper SL-94-1  
April 1994

## Efflorescence Study, Fort Leonard Wood, Missouri

by Tony B. Husbands

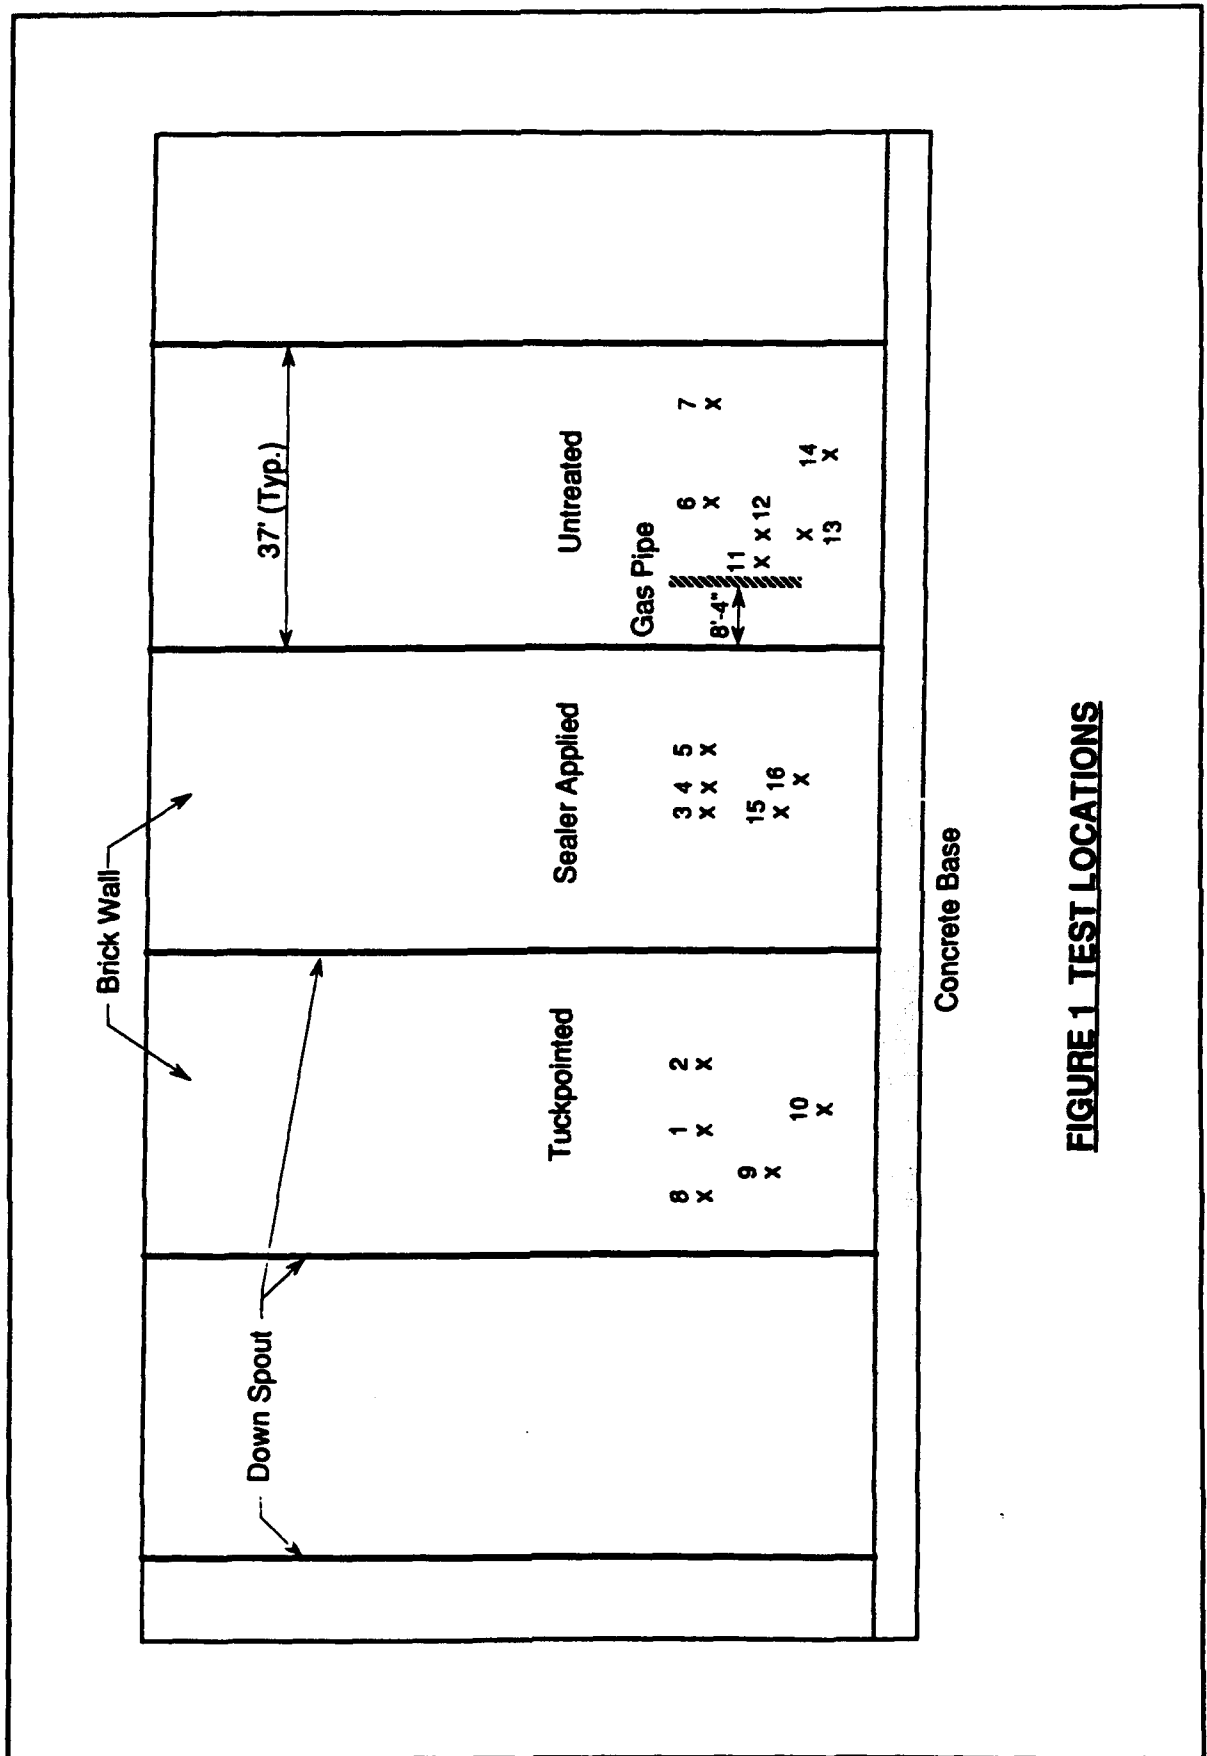
**FIGURE 1 TEST LOCATIONS**

cracked. A high flow rate ( $>40$  mL/min) was obtained indicating a deep opening in the crack. This could be another source for water entry into the wall. One test was performed at the intersection of two joints, where debonding appeared, and a flow rate of 40 mL/min was obtained. The other test locations on joints did not have excessive water penetration; however, no cracks were observed at these locations.
